Appendix E: River Condition Assessment

Keuper Gas Storage Project

Client name	Keuper Gas Storage Limited
Project name	Keuper Gas Storage Project
Project number	EN0310001
Report title	Appendix E: River Condition Assessment
Issue number	Final
Date	26/09/2025
Written by	Libby Norton Field Ecologist Niamh Sherborne Senior Ecologist
Checked and approved by	Charlotte Haylock Senior Ecologist

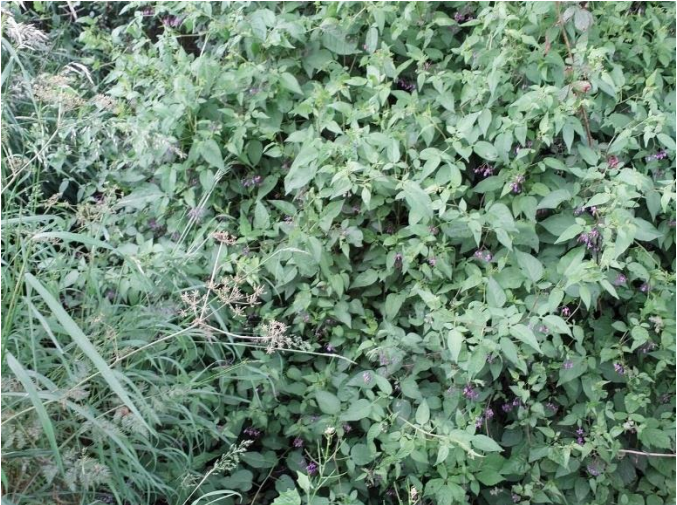
No.	Description	Photograph
1	Overgrown river bank and river top vegetation blocking view of the river channel

Access was only possible from one side of the bank for the majority of the survey due to dense vegetation growth and/or field boundaries preventing access. However, due to the narrow watercourse width this was not considered a constraint to the survey as the opposite bank top and face could be easily seen.

Steep bank sides and dense vegetation growth meant that the channel bed and bank sides were obscured in some areas.

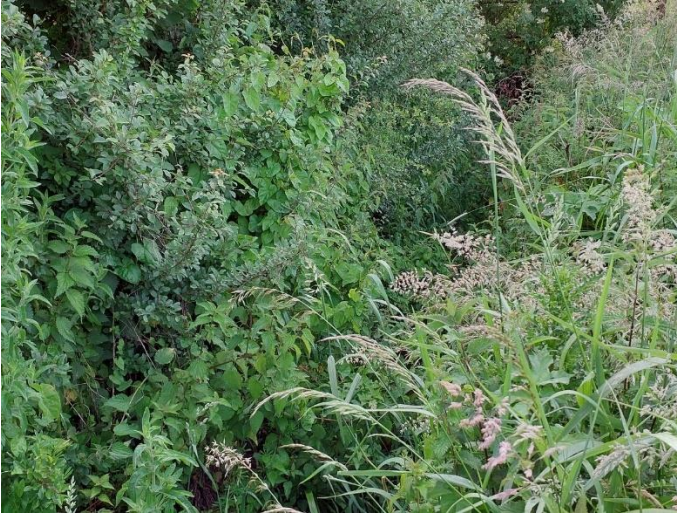
2	Overgrown bank face vegetation

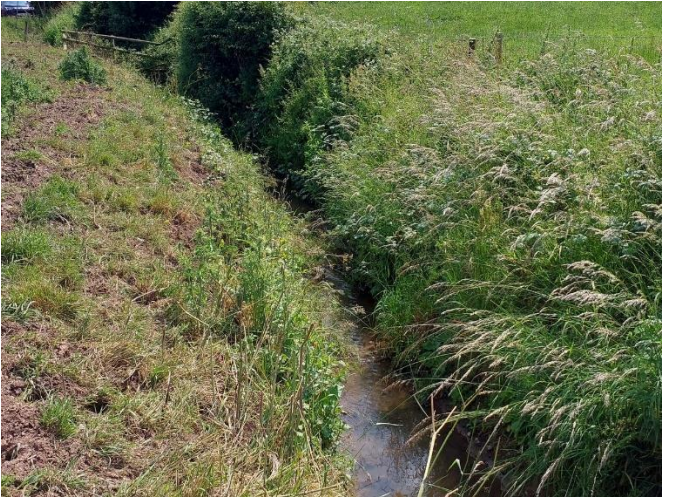
3	Dredged channel with artificial steep sides

Where a river is considered to be overdeep, the final condition class should be reduced by one class level. For the surveyed sub-reaches, the river shape scores were consistent with our assessment that the watercourse was overdeep partially due to historical management including dredging.
